LEBANON 044/103

I-89 SB over CONNECTICUT RIVER, NECRR

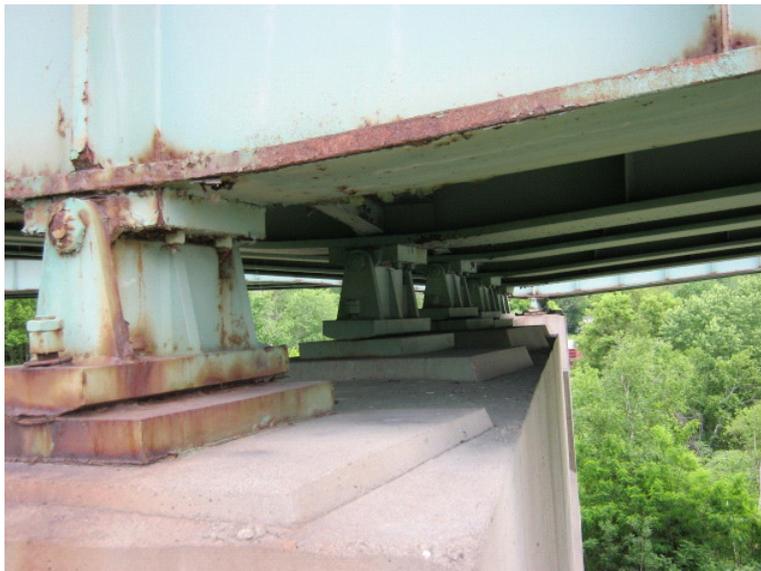
B467 03

BEARINGS PIER 5.

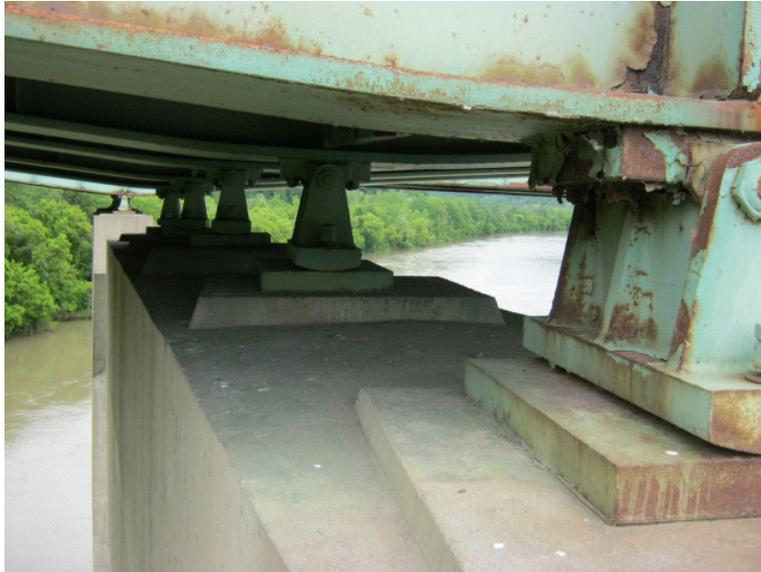
B467 04

BEARINGS PIER 4.

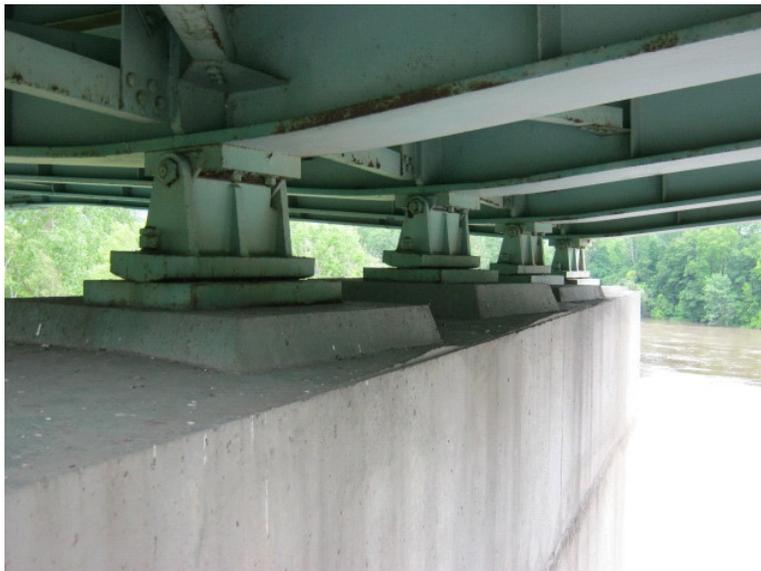
B467 12

BEARINGS PIER 1.

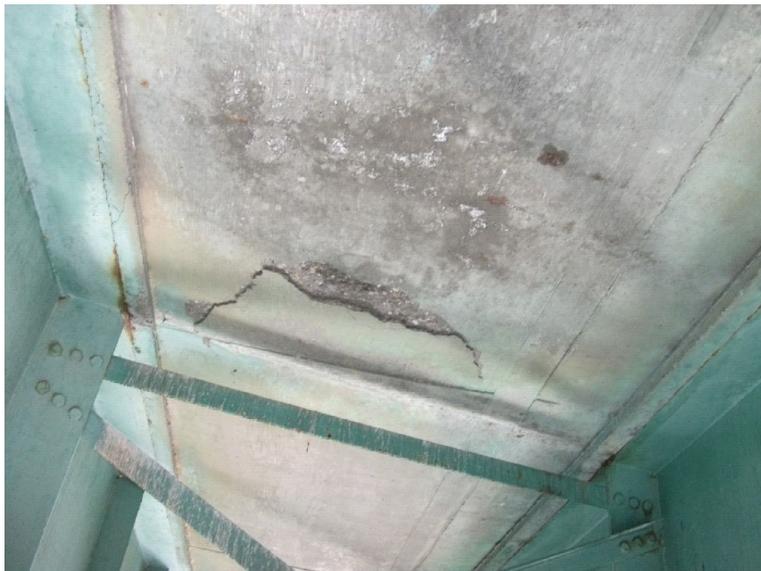
B431 20

DELAMINATION IN SPAN 2
BAY 1.

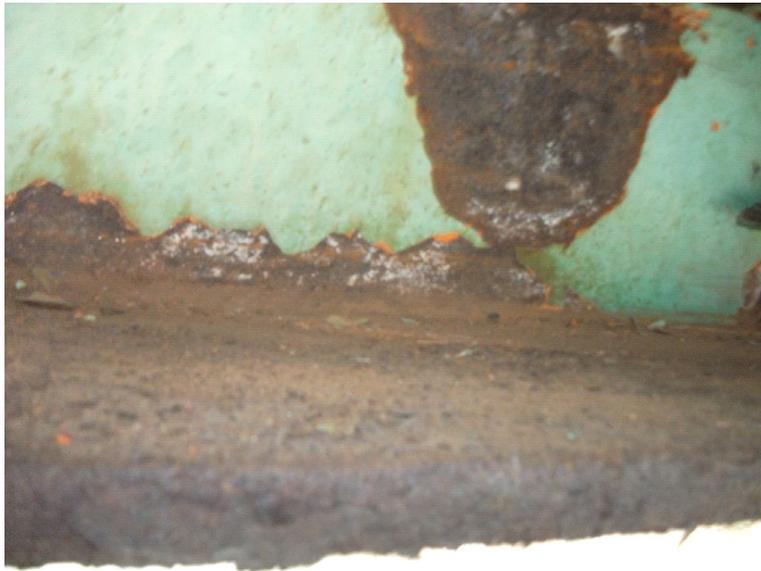
B417 43

BEAM 1 SPAN 3 INTERIOR
WEB SCALING.

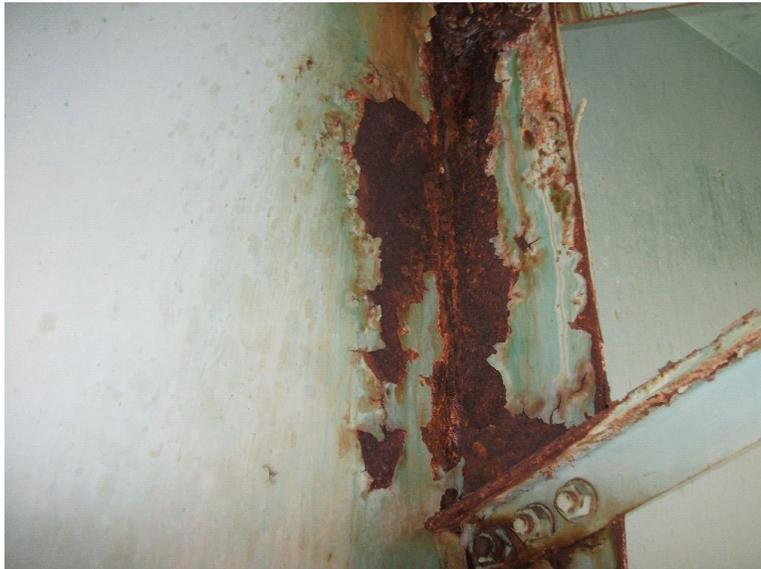
B417 44

BEAM 4 SPAN 4 SCALING.

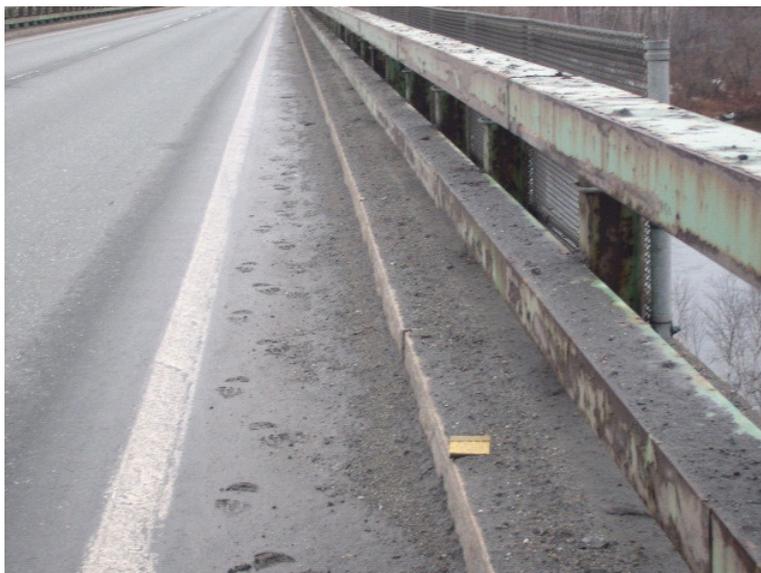
B360 12

DIRT AND DEBRIS BUILD UP
AT CURBS, TYPICAL.

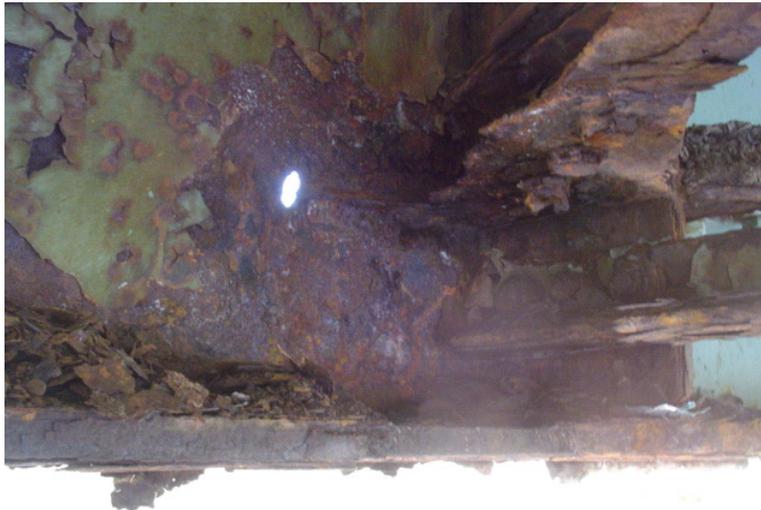
A220 12

GIRDER #1 WEB HOLED AT BRACING FRAME GUSSET PLATE ATTACHMENT, SPAN #3 AT RELIEF JOINT.

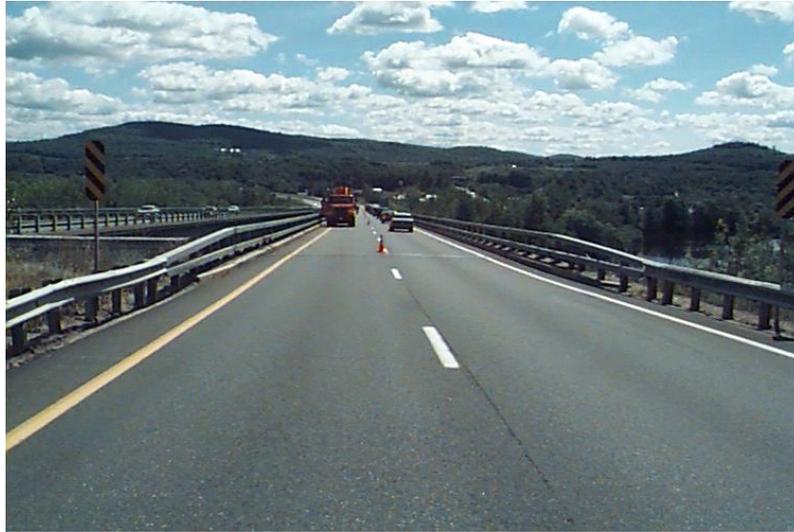
A047 37

NORTH APPROACH.

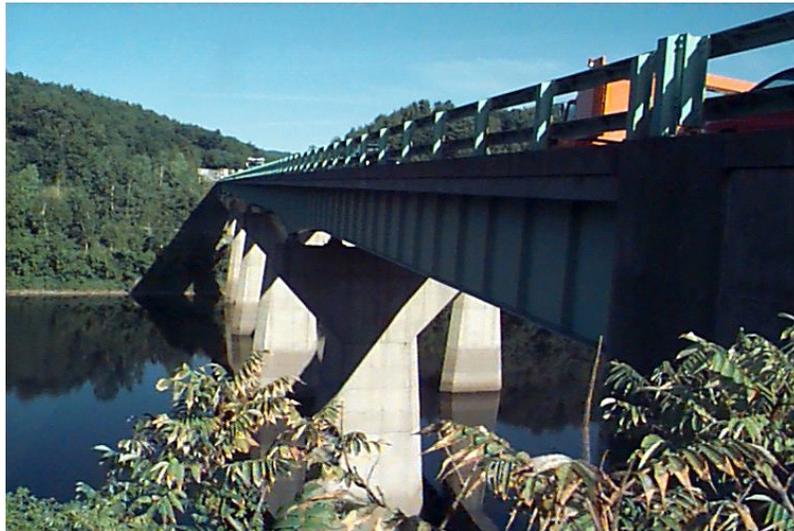
A047 33

DOWNSTREAM (SW)
ELEVATION.
